# Sentinel-1 DInSAR for Monitoring Active Landslides in Critical Infrastructures: The Case of the Rules Reservoir (Southern Spain)

**Abstract:** Landslides in reservoir contexts are a well-recognised hazard that may lead to dangerous situations regarding infrastructures and people's safety. Satellite-based radar interferometry is proving to be a reliable method to monitor the activity of landslides in such contexts. Here, we present a DInSAR (Differential Interferometric Synthetic Aperture Radar) analysis of Sentinel-1 images that exemplifies the usefulness of the technique to recognize and monitor landslides in the Rules Reservoir (Southern Spain). The integration of DInSAR results with a comprehensive geomorphological study allowed us to understand the typology, evolution and triggering factors of three active landslides: Lorenzo-1, Rules Viaduct and El Arrecife. We could distinguish between rotational and translational landslides and, thus, we evaluated the potential hazards related to these typologies, i.e., retrogression (Lorenzo-1 and Rules Viaduct landslides) or catastrophic slope failure (El Arrecife Landslide), respectively. We also observed how changes in the water level

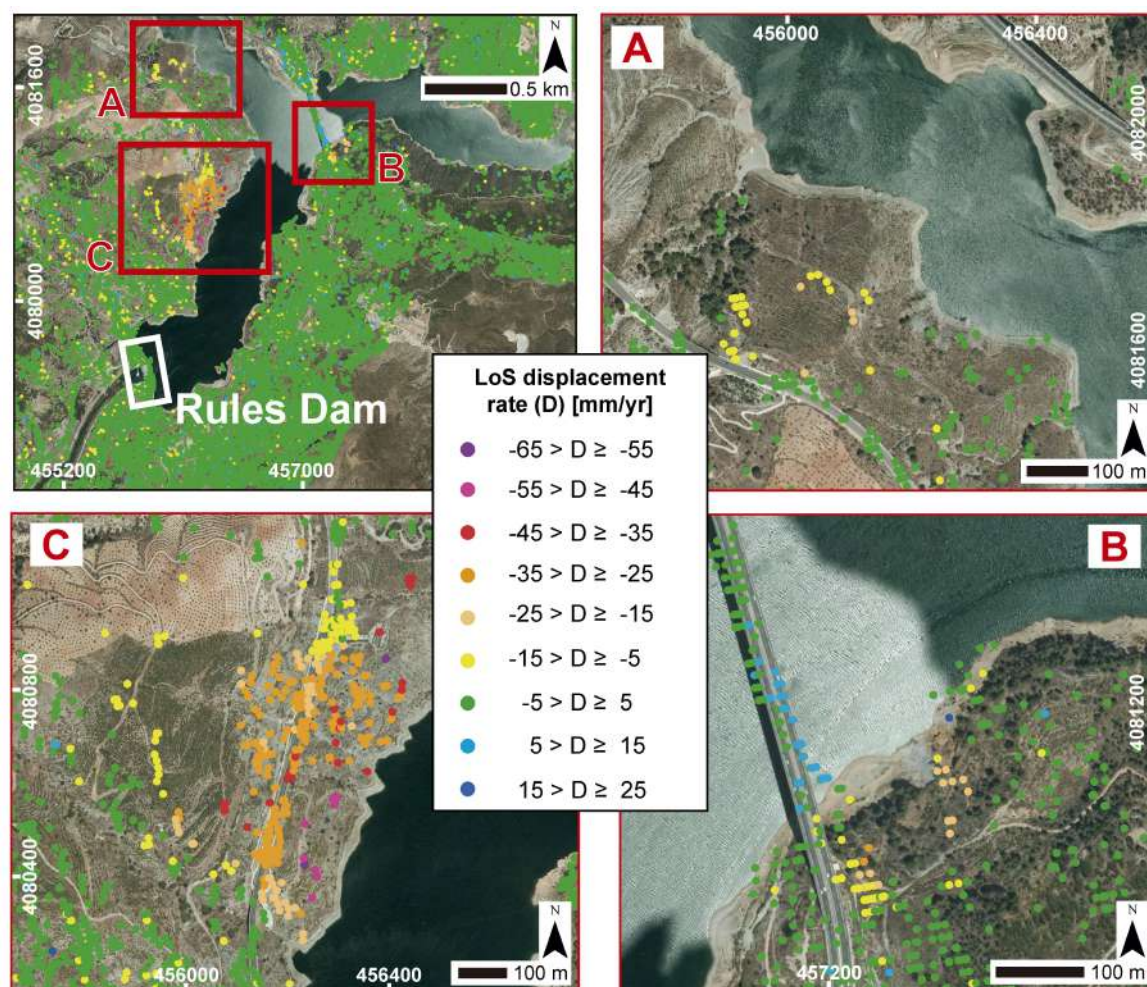
**Figure 3.** Surface velocity map of the Rules Reservoir area. The Cortijo de Lorenzo area (A), the Rules Viaduct Landslide (B) and the El Arrecife Landslide (C) are shown in greater detail.

The non-stable points are concentrated mainly in three areas (Figure 3): (A) the Cortijo de Lorenzo area, along the Ízbor River branch of the reservoir, (B) the southern edge of the Rules Viaduct and (C) the El Arrecife area, along the western slope of the Rules Reservoir. The Cortijo de Lorenzo area generally presents evidence of slope instability, mainly linked to a landslide that we named as Lorenzo-1 Landslide. Velocity rates reach 20 mm/year as maximum (Figure 3A). In the southern slope of the Rules Viaduct, we detected velocities in the range of  $-5.5$  to  $-24$  mm/year (Figure 3B), with  $-15$  mm/year as the mean velocity. Most of the points are settled close to the viaduct itself, while another set of points are settled 150 m away to the northeast of the viaduct (Figure 2B), located within a landslide that was inventoried by Fernández et al. 1997 [43] and Chacón et al. 2007 [44]. We named this landslide as 'Rules Viaduct Landslide'. Lastly, in the El Arrecife area, we obtained velocities ranging from  $-10$  to  $-60$  mm/year and the mean velocity was  $-25$  mm/year. Most of the points are distributed along the N-323 National Road and the lowest part of the same slope (Figure 3C). The set of points with the highest velocities (around  $-50$  and  $-55$  mm/year) corresponded to a small-sized landslide also inventoried by Fernández et al. 1997 [43] and Chacón et al. 2007 [44]. The instability of this area was also pointed out by Lackezy et al. 2016 [51], but the spatial pattern of the velocities obtained by these authors prevents a detailed delimitation of the sliding mass. Our surface velocity map gave us a better insight into the landslide boundaries that we named as 'El Arrecife Landslide'. Additionally, we could observe that the southern lateral limit of this landslide shows an abrupt change in terms of velocity values, while the northern limit shows a gradual velocity evolution (Figure 3C).

From our InSAR data, we also found out that the Rules Dam and the slopes on which the structure rests show no displacement (Figure 3). Within both slopes, Fernández et al. 1997 [43] firstly mapped two large landslides that we named as ‘Ventura Landslide’, a Deep-Seated Gravitational Slope Deformation (DSGSD), and ‘Los Hoyos Landslide’, a rock slope failure (RSF) of the lateral spread type (Figure 4). Moreover, other critical structure in the study area seems to be affected by a slight deformation also detected through our DInSAR analysis. Along the southern edge of the Rules Viaduct, we obtained a set of points showing positive values of displacement rates between 7 and 10 mm/year (Figure 3B), which indicates a slight displacement of this viaduct segment.

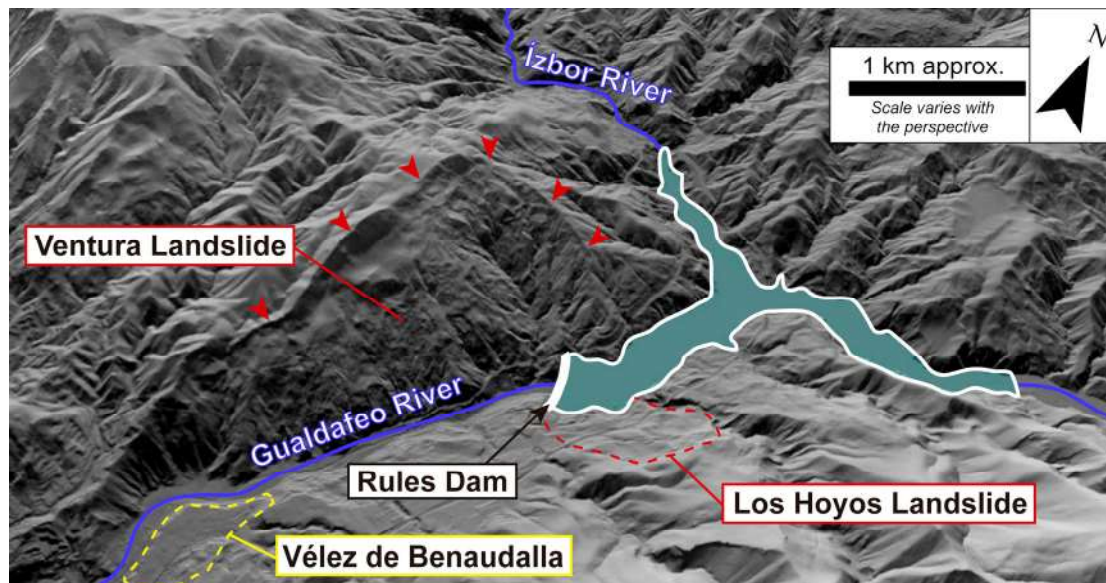
**Figure 4.** Oblique northwestward view of a hillshade model of the Rules Reservoir area. Red triangles point out to the main scarp (i.e., crown) of the Ventura landslide, its most clear geomorphic feature. Note the dimensions of the Los Hoyos Landslide and Ventura Landslide at both sides of the Rules Dam.

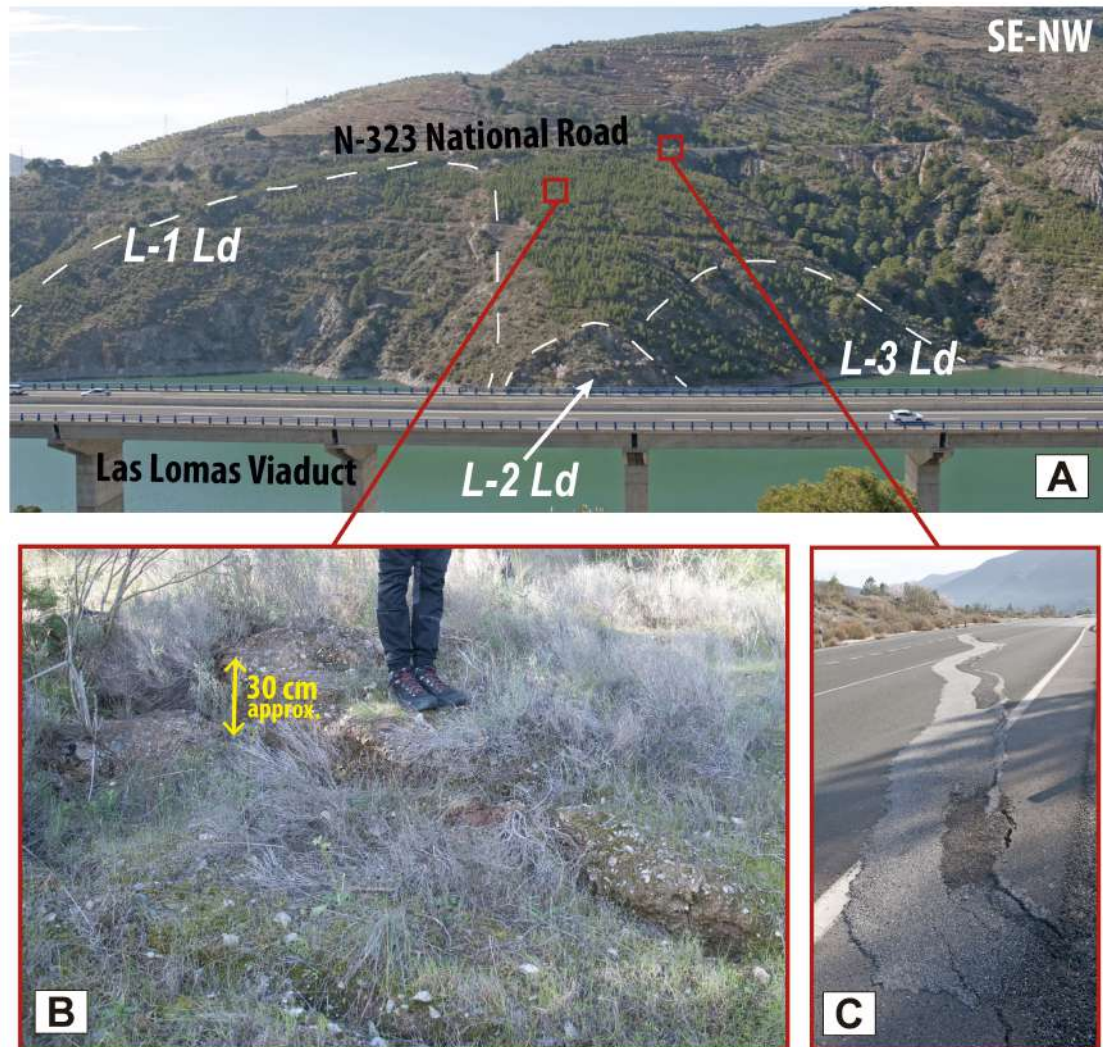
**Figure 7.** (A) Photograph of the Cortijo de Lorenzo area. The Lorenzo-1 Landslide, Lorenzo-2 Landslide and Lorenzo-3 Landslide are abbreviated as L-1 Ld, L-2 Ld and L-3 Ld, respectively. (B) Opened cracks next to the head scarp of the Lorenzo-1 Landslide. Notice the vertical slip of 30 cm, as maximum. (C) Bump across the N-323 National Road.

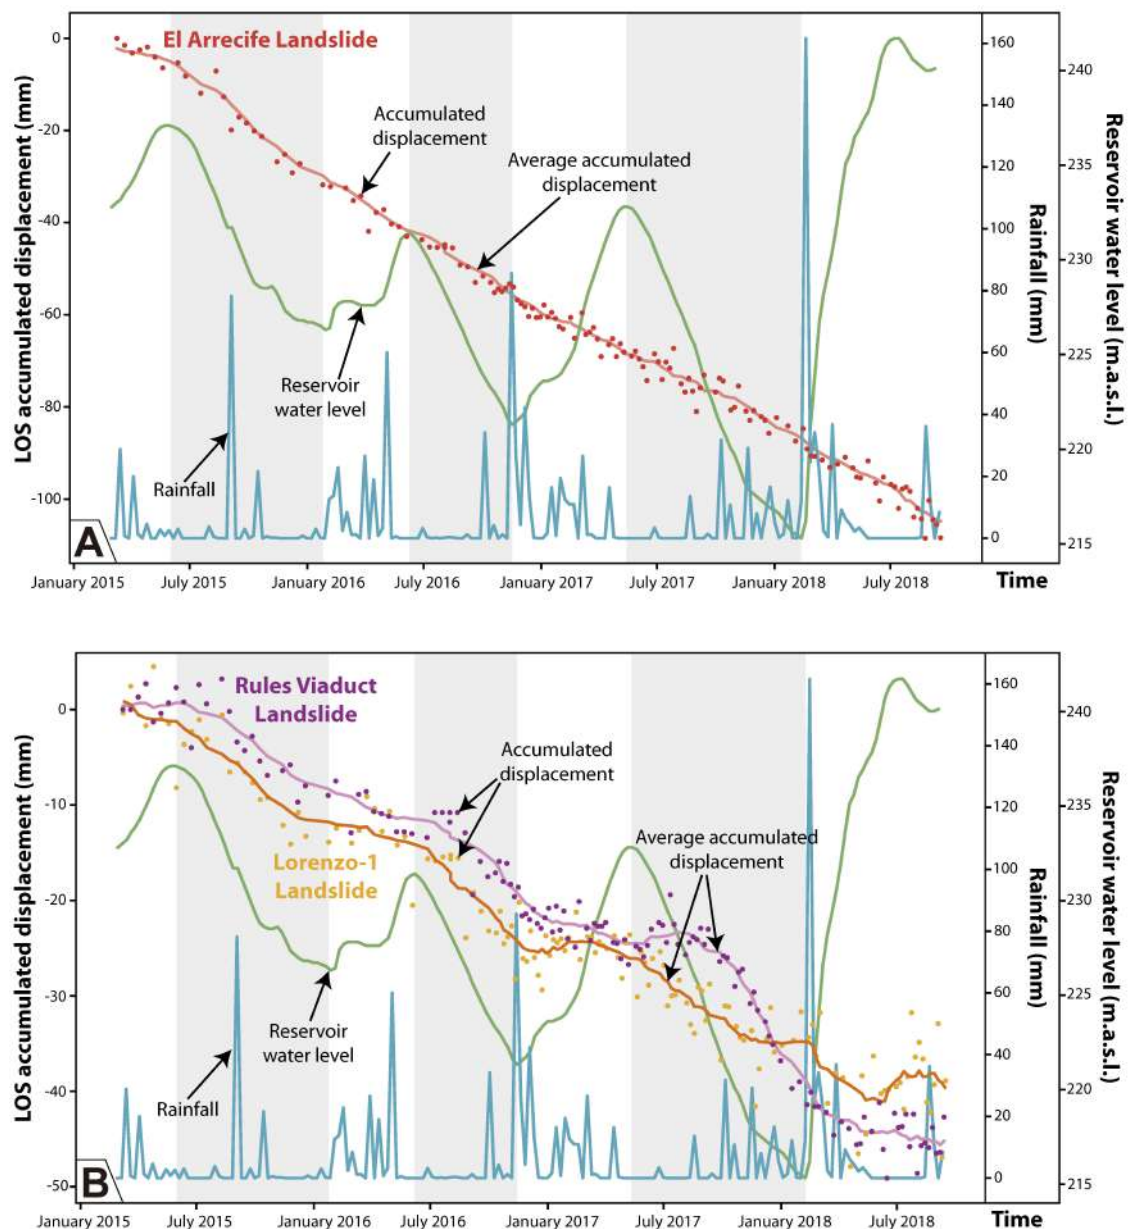
The most remarkable fact that we observed was the correlation between the Rules Viaduct and the Lorenzo-1 landslides’ TS, with variations in the water level of the reservoir. We identified three considerable drops of the water level that coincide with three periods of acceleration of the movement, that are evidenced by a change in the slope of the average accumulated displacement rate (Figure 12B). The first and the second periods of acceleration corresponds to autumn 2015 and summer–autumn 2016, respectively, while the third and the longest period of acceleration occurs from summer 2017 to winter 2018 (Figure 12B). On the contrary, displacement is not accelerated when water level increases, which depends directly on the amount of rainfall. The El Arrecife Landslide TS shows a slight acceleration period during autumn 2015, also correlated with a decrease in the water level reservoir (Figure 12A).

**Figure 12.** Time series in the line of sight of accumulated displacement of the El Arrecife Landslide (A) and both the Rules Viaduct Landslide and Lorenzo-1 Landslide (B). 7 days cumulative rainfall and water level of the Rules Reservoir are also represented. Grey columns indicate periods of reservoir drawdown.

In the case of both the Lorenzo-1 and Rules Viaduct landslides, there is a clear anthropic influence favouring the acceleration of the movements (i.e., anthropic triggering factor): the changes in the water level of the reservoir. As shown in Figure 12B, the three periods of acceleration in both landslides are

related to periods of drawdown of the water level, while periods of no variation or increase in the water level result in stabilization. Such a correlation has also been documented in multiple reservoir slides as a result of either filling or drawdown of the reservoir (e.g., [4–11]). In contrast, the sudden drawdown of a reservoir can threaten stability as a result of removing the lateral confining pressure (water) of the reservoir slopes, and the mass of soil still has a reduced shear strength [3]. In the case of the Grand Coulee Reservoir in the USA [4], at least 150 landslides were documented, due to periods of water level drawdown. As another example, in the Three Georges Reservoir area, Liao et al. 2005 [58] concluded that reservoir drawdowns and the descending velocity of the drawdown become major factors that affect the stability of landslides. We also regard the detected inverse relationship between rainfall and acceleration of movement within the above-mentioned landslides as interesting. Rainfall usually reduces the effective shear strength of failure surfaces [59], and thus increases the potential of sliding. This fact has been evidenced by several authors [60–63] that link the reactivation, acceleration or higher occurrence of landslide activity to heavy rainy periods. Contrary to this literature, both the Rules Viaduct Landslide and Lorenzo-1 Landslide show a deacceleration in movement related to rainfall peaks (Figure 12B). As rainfall conducts the reservoir filling, lateral confining pressure increases (as a result of a water level increase) and, thus, landslide displacement decreases, leading to a relative stabilization of the slopes. These examples show how water level variation has a stronger influence on landslide displacement patterns than rainfall. Moreover, this paper represents the first clear detection of this behaviour using DInSAR techniques. The high temporal resolution of the Sentinel-1 images has made this possible.

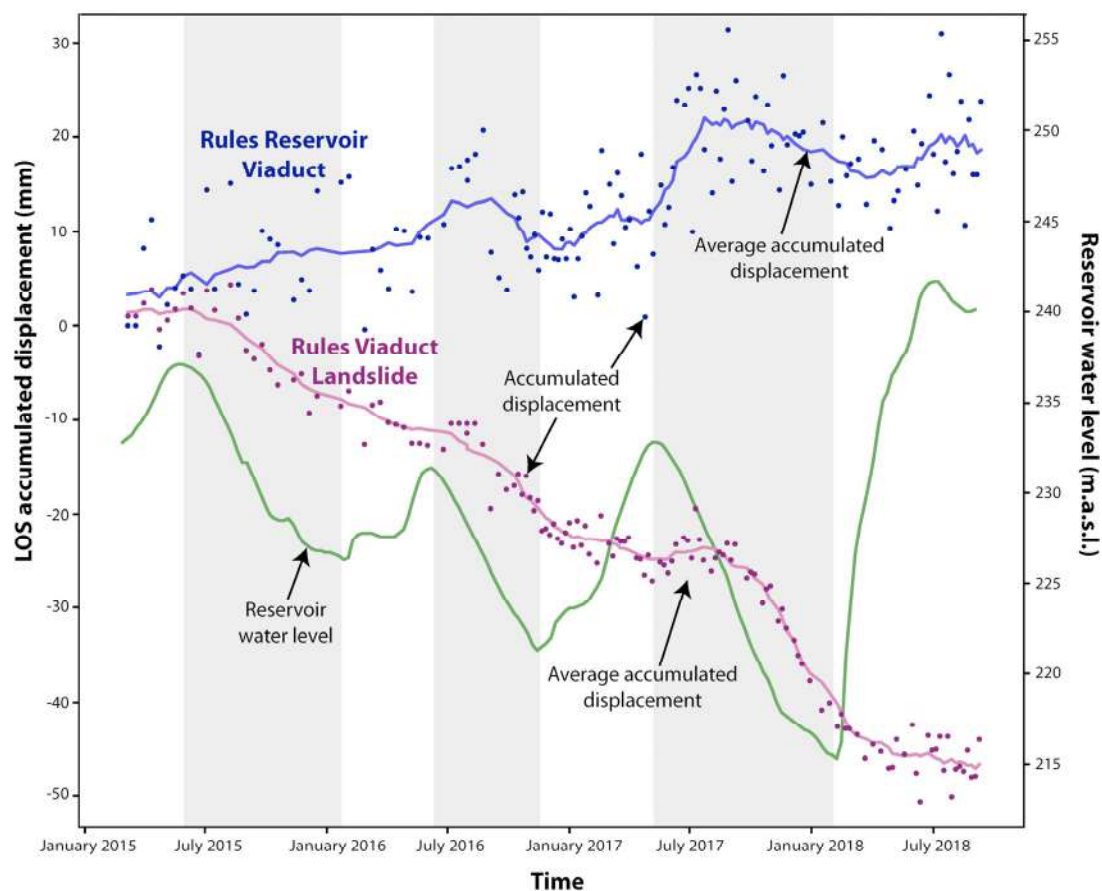
Regarding the unstable points along the Rules Viaduct, the time series shows periods of displacement coinciding with drawdowns in the water level reservoir (Figure 13). Thus, we identified three acceleration pulses during the springs of 2015, 2016 and 2017 (Figure 13).

**Figure 13.** Time series in line of sight of accumulated displacement of the Rules Viaduct Landslide and the Rules Viaduct. Water level of the Rules Reservoir is also represented. Grey columns indicate periods of reservoir drawdown. Note the noise of the Rules Viaduct TS in comparison with the Rules Viaduct Landslide TS.

According to the above arguments, the Lorenzo-1 and the Rules Viaduct landslides, due to their dimensions and rotational character, do not represent a significant hazard for the reservoir shorelines or the dam. An extremely rapid acceleration in these landslides and their sudden collapse into the reservoir may be possible, but is unlikely, due to their characteristics and observed behavior, if reservoir water level management is done properly. However, the main risk associated to these landslides is their retrogressive evolution, that may affect the southern abutment and pillars of the Rules Viaduct (in the case of the Rules Viaduct Landslide) or the N-323 National Road (in the case of the Lorenzo-1 Landslide) in future. Therefore, it must be a priority to keep monitoring the evolution of these landslides as well as to analyse the deformation detected along the southern segment of the Rules Viaduct (Figure 13). If

the displacements are validated using other geodetic techniques, any required reinforcement works should be carried out far enough in advance to avoid severe damage to the viaduct (as happened in the last decade) in order to reduce repair costs. The origin of this deformation is still unknown, but we have hypothesised different scenarios to explain it: (1) horizontal flexural deformation due to the activity of the Rules Viaduct Landside (see [65] as an example). Notice the slight correlation between periods of acceleration of the viaduct and the landslide (Figure 12). (2) Thermal dilation of the viaduct (see [66] as an example). The correlation between periods of acceleration of the viaduct (i.e., uplifting) with summer and the hottest months would support this theory (Figure 13). In any case, our InSAR data seems to indicate that the southern pile could be affected by a certain kind of instability that must be further investigated and monitored.
