# Sentinel-1 DInSAR for Monitoring Active Landslides in Critical Infrastructures: The Case of the Rules Reservoir (Southern Spain)

**Abstract:** Landslides in reservoir contexts are a well-recognised hazard that may lead to dangerous situations regarding infrastructures and people's safety. Satellite-based radar interferometry is proving to be a reliable method to monitor the activity of landslides in such contexts. Here, we present a DInSAR (Differential Interferometric Synthetic Aperture Radar) analysis of Sentinel-1 images that exemplifies the usefulness of the technique to recognize and monitor landslides in the Rules Reservoir (Southern Spain). The integration of DInSAR results with a comprehensive geomorphological study allowed us to understand the typology, evolution and triggering factors of three active landslides: Lorenzo-1, Rules Viaduct and El Arrecife. We could distinguish between rotational and translational landslides and, thus, we evaluated the potential hazards related to these typologies, i.e., retrogression (Lorenzo-1 and Rules Viaduct landslides) or catastrophic slope failure (El Arrecife Landslide), respectively. We also observed how changes in the water level

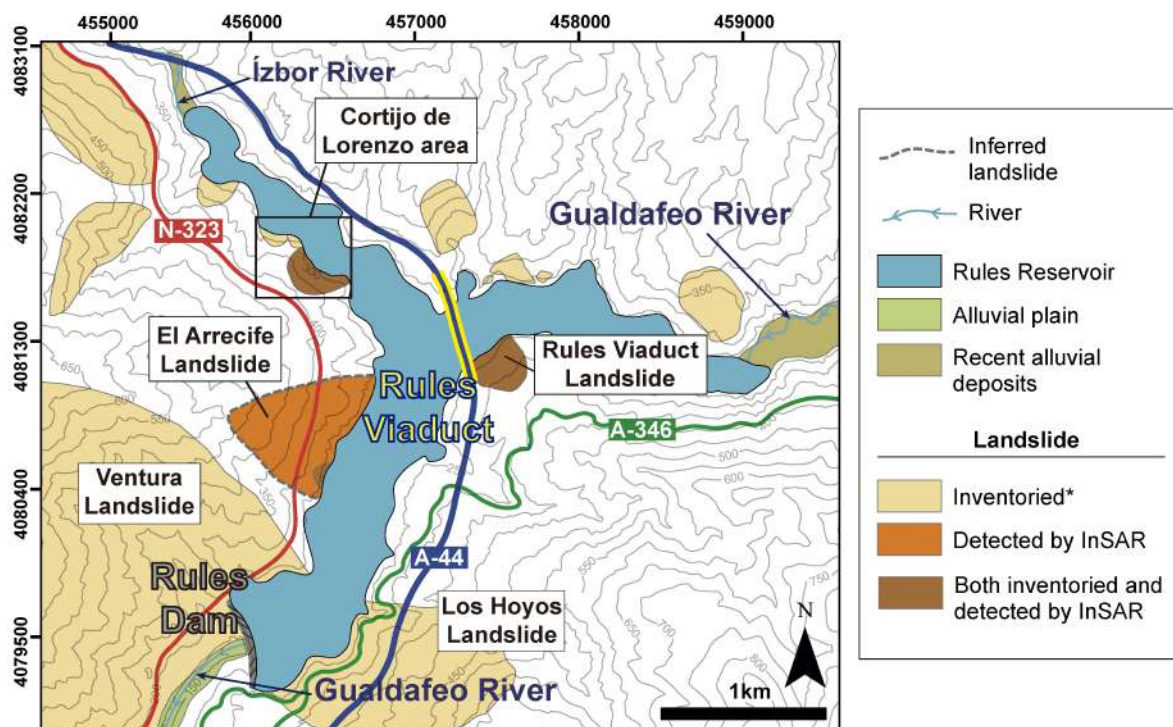
According to the first category, we included those landslides that were considered in the Fernández et al. 1997 [43] landslide inventory and are clearly recognisable in the landscape at the present time. We inventoried twelve landslides of different dimensions, two of which we consider to be of particular relevance: ‘Ventura Landslide’ and ‘Los Hoyos Landslide’, due to its direct relationship to the Rules Dam (Figures 4 and 5). As mentioned above, we did not detected displacement within both landslides. The second category includes the ‘El Arrecife Landslide’ (Figure 5) that we delimited in terms of the non-stable InSAR points distribution. This landslide is not easily identifiable in the landscape as it does not show a prominent head scarp or any other landslide-related morphology within the slope. The last category includes two landslides that were inventoried by Fernández et al. 1997 [43] and Chacón et al. 2007 [44] and also present evidences of activity by our InSAR results. These landslides are the ‘Rules Viaduct Landslide’, located next to the southern edge of the Rules Viaduct, and the ‘Lorenzo-1 Landslide’, located in the Cortijo de Lorenzo area, along the Ízbor River branch of the Rules Reservoir (Figure 5). Further geomorphological characteristics of each area of study are described below.

**Figure 5.** Landslide inventory of the most representative landslides of the Rules Reservoir area.

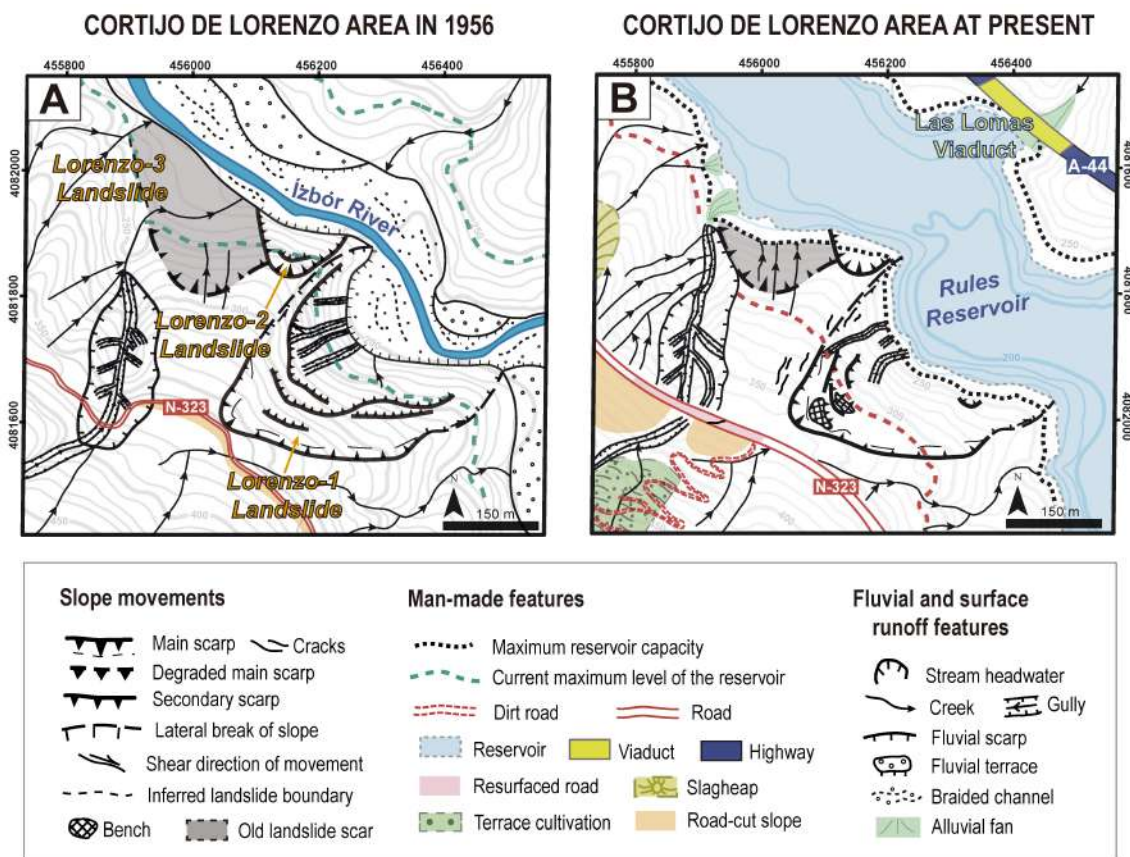
The Cortijo de Lorenzo consists of an area of 0.6 km<sup>2</sup>, located in the northwestern part of the Rules Reservoir (Figure 5) and corresponding to the Ízbor River branch of the reservoir. We mapped three landslides in this area (Figure 6): (1) Lorenzo-1 Landslide, which is the biggest one and clearly shows morphological features of a rotational landslide. It was already inventoried by Fernández et al. 1997 [43] and Chacón et al. 2007 [44] (Figure 5); (2) Lorenzo-2 Landslide, the smallest landslide; and (3) Lorenzo-3 Landslide, that is considerably older than the others (grey-coloured in Figure 6) as it is almost covered by vegetation and presents alluvial erosion features (Figure 7A). All of these landslides involve Alpujárride phyllites. At the present time, the reservoir water has covered a considerable part of these landslides, which is especially noticeable within Lorenzo-3 Landslide (Figure 6B). In the field, we observed several opened and fresh cracks within the landslide, what indicates its activity. We also found opened cracks and active piping away from the landslide perimeter (Figure 7B), that evidences a landslide retrogression towards the west of the slope. These field observations are corroborated by the moving points of our InSAR velocity map (Figure 3A). The reconstruction and resettlement of the N-323 National Road has slightly modified the surface runoff dynamics along a well-incised creek (Figure 6). Part of this new trace has been recently resurfaced and it presents a large bump that crosses the road (Figure 7C), probably due to slope instability processes along the creek that have also been evidenced by our InSAR results (Figure 3A).

**Figure 6.** Geomorphological maps of the Cortijo de Lorenzo area in 1956–1957 (A) and at present (B).

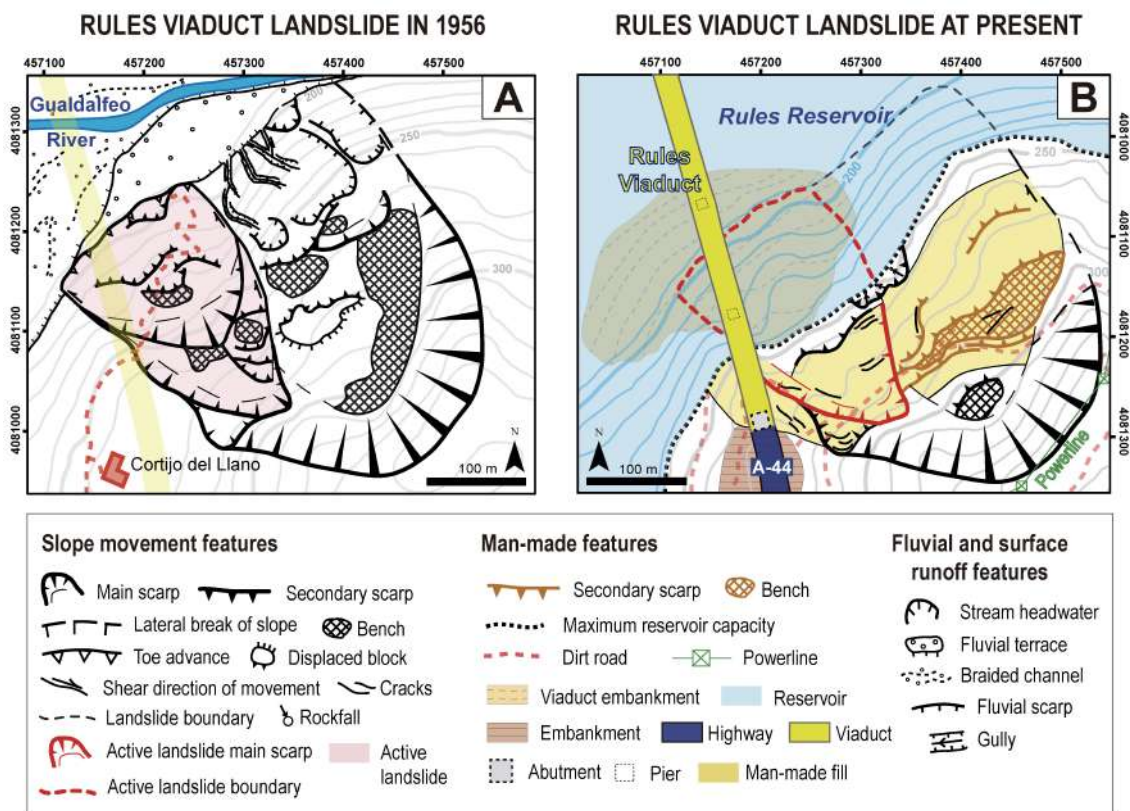
Through the aerial photographs taken by the 1956–1957 American Flight, we were able to map several geomorphological features that had been highly modified or disappeared since the construction of the reservoir (Figure 8). The landslide had an area of 0.1 km<sup>2</sup> (345 m length and 330 m width) and a clear head scarp with an amphitheatre shape (Figures 8 and 9A). The slope morphology and the involved geomorphological features have led us to define this landslide as a retrogressive rotational type. This is evidenced by a system of secondary scarps and related benches, as well as by a big tilted block of marbles (Figure 8A). In such cases, the overlying Alpujárride marbles slide over the phyllites, as we could observe in the main head scarp and also in some secondary scarps. We classified the western part of the landslide as a differentiated and active landslide, whose morphology is evidenced by separated head scarps, secondary scarps, benches and a well-defined lateral break in slope (Figure 8A). We induced its activity as we could observe a clear toe advance of this landslide, not observed within the presumed non-active sector (Figure 8A). Alluvial erosion and the formation of gullies also evidence no movement and stability in this part of the landslide. As previously mentioned, most of the original geomorphological features have been removed, modified or covered by man-made filling (Figure 8B). In this way, the landslide toe has been removed and covered by the reservoir water, while the western sector (i.e., active landslide) has been replaced by an embankment for the Rules Viaduct, where one of the viaduct piers is located (Figure 8B). Almost the entire remaining landslide has been infilled with materials coming from the construction works. As a consequence, most of the secondary scarps and benches have disappeared. Part of the active landslide and the main scarps are still visible, but secondary scarps and benches have been removed or covered. We found active piping and opened, fresh cracks within the infilling material (Figure 9B,C), especially near the head scarp of the active landslide, which evidences its activity. Cracks are also found away from the landslide perimeter, also covered by infilling materials, and next to the A-44 Highway southern abutment (Figure 9B).

This field evidence and the displacements shown in the InSAR velocity maps (Figure 3B) indicate a hazardous landslide, with retrogressive evolution towards the west-southwest, i.e., towards the southern abutment of the viaduct.

**Figure 8.** Geomorphological maps of the Rules Viaduct Landslide in 1956–1957 (A) and at present (B).

the displacements are validated using other geodetic techniques, any required reinforcement works should be carried out far enough in advance to avoid severe damage to the viaduct (as happened in the last decade) in order to reduce repair costs. The origin of this deformation is still unknown, but we have hypothesised different scenarios to explain it: (1) horizontal flexural deformation due to the activity of the Rules Viaduct Landside (see [65] as an example). Notice the slight correlation between periods of acceleration of the viaduct and the landslide (Figure 12). (2) Thermal dilation of the viaduct (see [66] as an example). The correlation between periods of acceleration of the viaduct (i.e., uplifting) with summer and the hottest months would support this theory (Figure 13). In any case, our InSAR data seems to indicate that the southern pile could be affected by a certain kind of instability that must be further investigated and monitored.

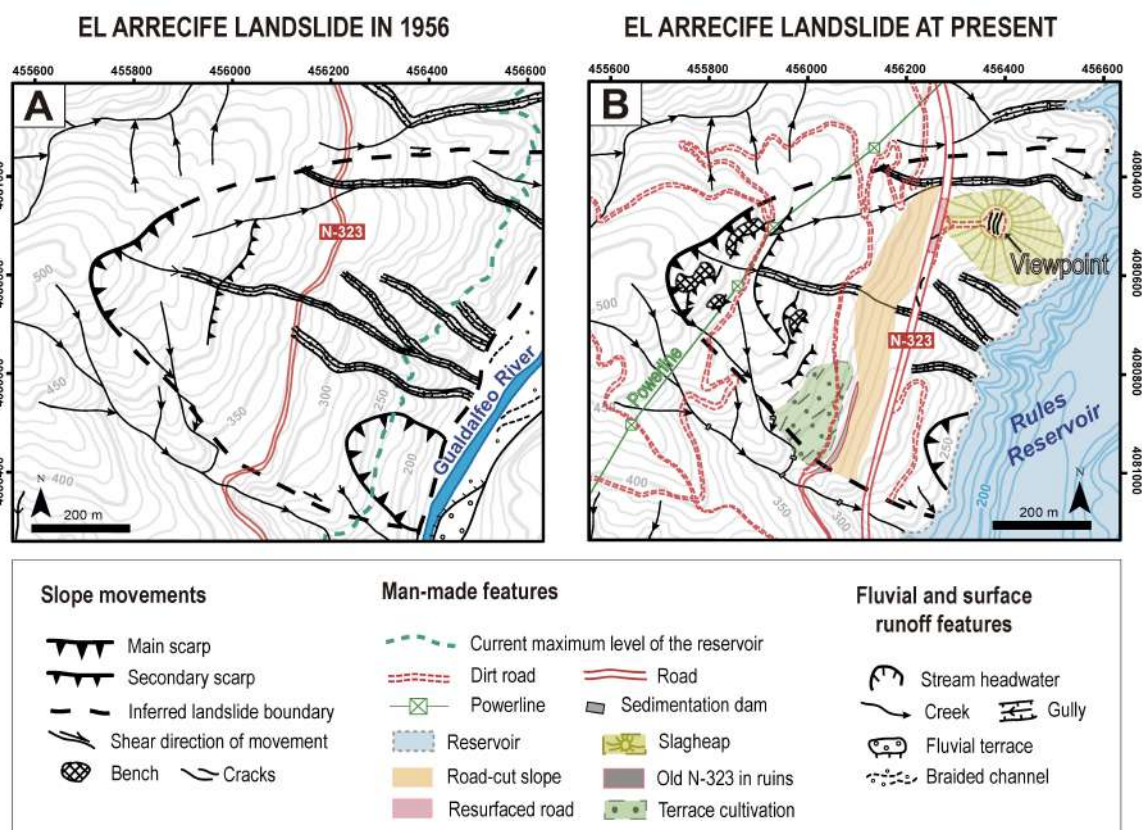
The El Arrecife Landslide (Figures 10 and 11A) had an area of 0.7 km<sup>2</sup>, 880 m length and 750 m width. This landslide involves Alpujárride phyllites and it looks like a translational landslide due to its roughly planar slope and the absence of a well-marked head scarp (Figure 11A). In the 1956–1957 aerial photographs, the landslide shows a non-prominent head scarp and almost no secondary scarp or lateral break of slope (Figure 10A). At the landslide foot, we could recognise a small landslide, inventoried by Fernández et al. 1997 [43] and Chacón et al. 2007 [44]. The slope, crossed by the N-323 National Road, was characterised by several incised gullies (Figure 10A) that indicate an a priori inactivity regarding gravitational processes. At present, the most remarkable features in the slope are the human modifications (Figure 10B). The main one is the road-cut slope built for a new trace of the N-323 road that was reconstructed 80 m downslope (Figure 10B). Part of the old N-323 is still visible in ruins, where we found numerous large opened cracks and pieces of pavement that have been sliced downhill (Figure 11B). The current road has been restored and resurfaced several times, probably due to the slope instability processes, which are also evidenced by recent oblique cracks, bumps (Figure 11C) and the undulating surface of the road (Figure 11D). The surface of a slagheap that was built to accumulate some of the residual material coming from the reservoir construction works was also paved to create a viewpoint (Figure 10B), but it has been quickly cracked due to the material compaction and progressive sliding. Other man-made features of the area at present are the construction of several field tracks and a powerline network.

**Figure 10.** Geomorphological maps of the El Arrecife Landslide area in 1956–1957 (A) and at present time (B).
